ASSESSMENT OF FIRE AND EXPLOSION HAZARDS IN LARGE-SCALE BATTERY ENERGY
STORAGE

SYSTEMS INTENDED FOR NAMIBIAN GREEN HYDROGEN PROJECTS

A THESIS SUBMITTED IN PARTIAL FULFILMENT OF THE REQUIREMENTS OF THE DEGREE

MASTER OF SCIENCE IN RENEWABLE ENERGY

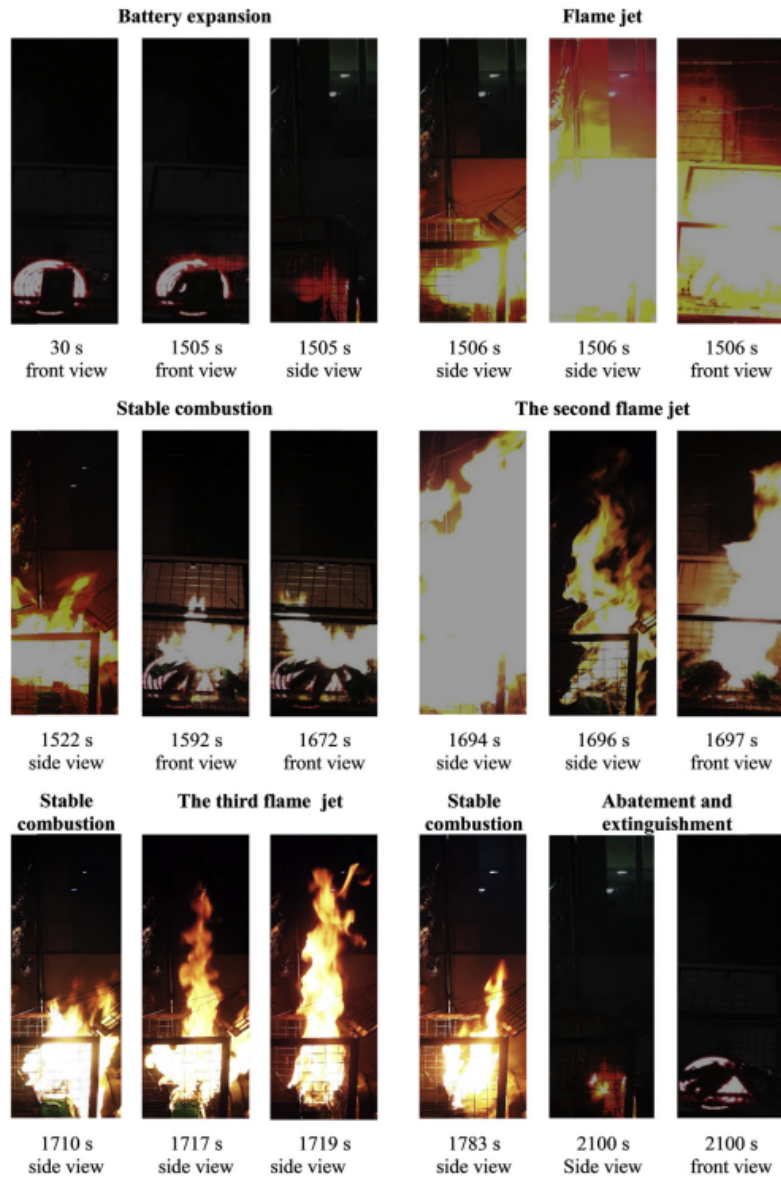
Figure 2. The combustion process in the 100% SOC battery’s full-scale burning tests. (With permission from author). This images show different stages of thermal runaway, including: battery expansion (30s - 1505s), jet flames (1506s), stable combustion (1522s – 1672s), second jet flame (1694s – 1697s), third jet flame (1710s – 1719s), stable combustion (1783s) and lastly the abatement and extinguishing at 2100s [31].

Fire behavior of the battery can be outlined as follows: battery swelling, initial jet flames, consistent burning, subsequent jet flame with stable burning, another cycle of jet flame with stable burning, mitigation, and extinguishing [31, 32]. The quantity of jet flames may vary depending on the state of charge (SOC) of the batteries [31, 32]. Figure 2 illustrates fire test that were carried out on the batteries with the 100% SOC by Ping et al. [31].

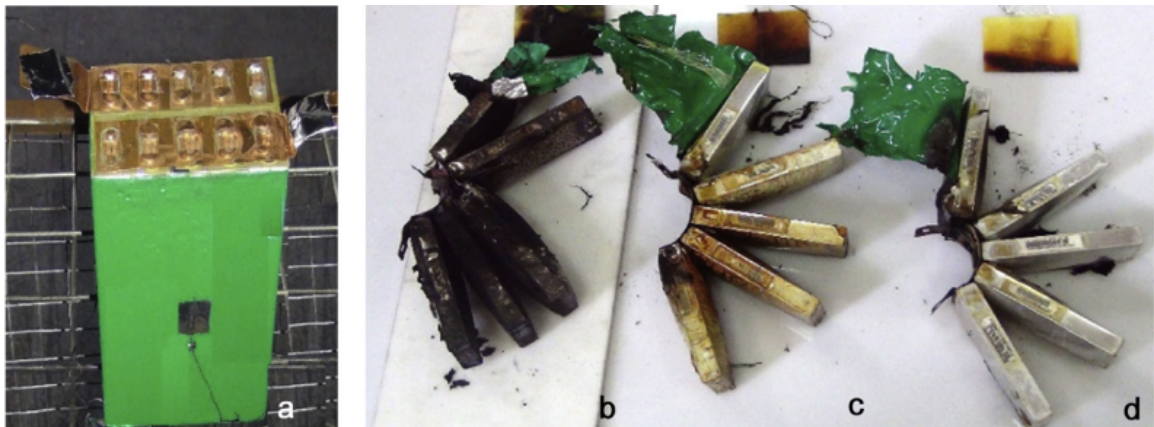
Figure 3. (a) 50 Ah LiFePO₄/graphite battery before the full-scale burning test; (b) 100% SOC, (c) 50% SOC and (d) 0% SOC batteries after full-scale burning tests. (With permission from author) [31].

off-gassing can also occur without immediate ignition, depending on the concentration. Batteries at full charge (100% SOC) are more likely to undergo severe thermal runaway and explosive reactions, but this not always the case. High energy content means there is more potential for violent reactions, leading to substantial damage. While batteries at 50% charge still contain a significant amount of energy, the risk of thermal runaway is relatively lower compared to the 100% SOC. The damage will be severe but generally less catastrophic than at full charge. Batteries at 0% SOC have the least amount of energy, reducing the risk of severe thermal events, however they can still suffer considerable damage due to internal chemical degradation, especially if exposed to high temperatures or mechanical stress. Even at 0% SOC, side reaction such as electrolyte decomposition or degradation of electrode materials can continue, potentially leading to internal short circuits. But it is less dramatic in terms of explosive potential [31]. Figure 3 shows the battery damage ratio based on the SOC of the battery.

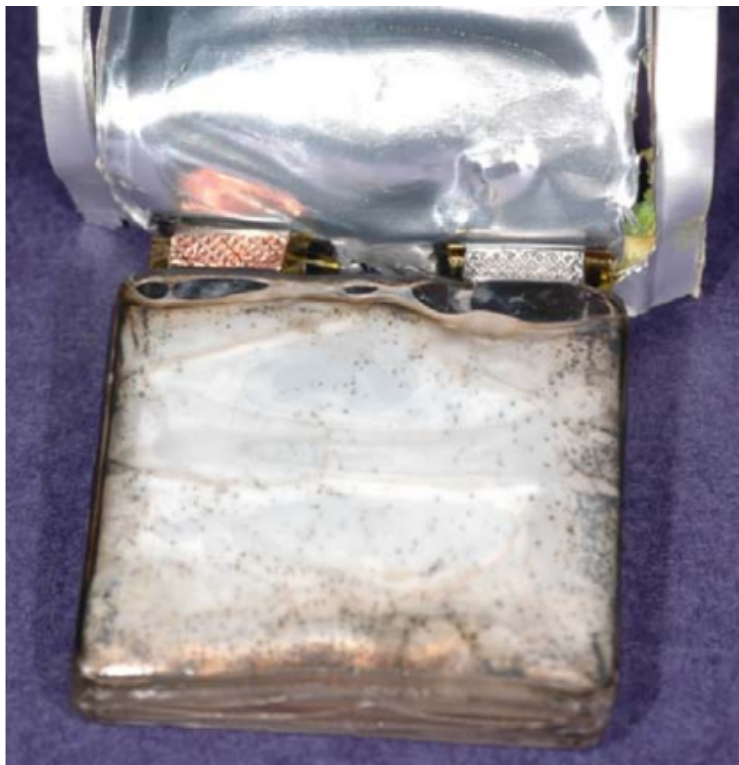
Figure 4. An example of a melting separator.

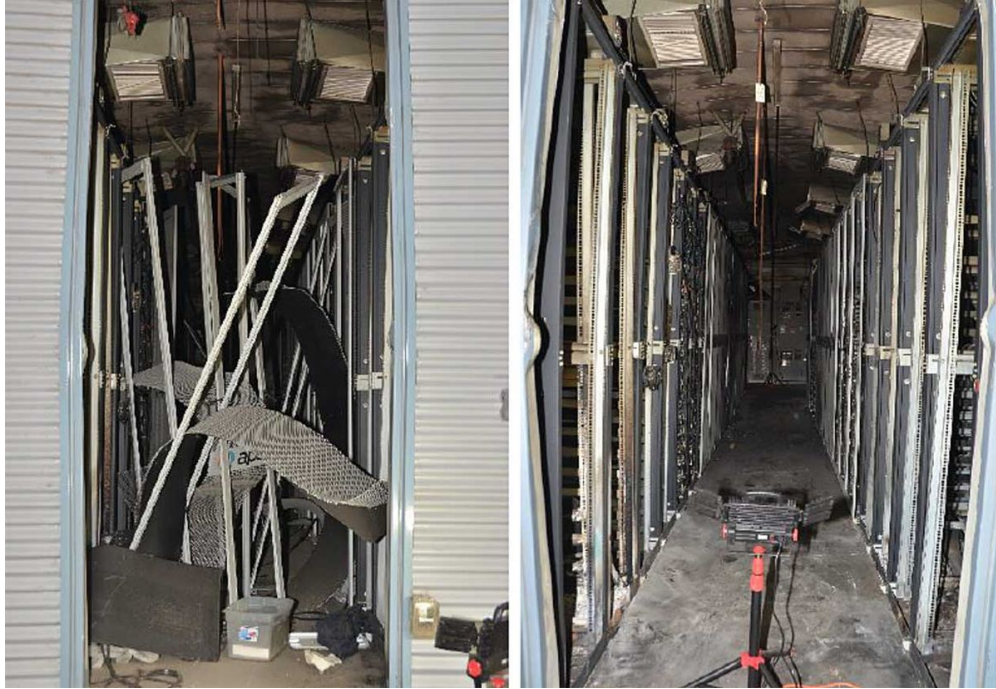
Figure 5. Damage to the BESS’s interior following the explosion (left), and following the removal of debris to allow entry for start of the forensics investigation (right) [37].

The APS McMicken facility in Surprise, Arizona, experienced a fire on April 19, 2019 [37]. After the fire started in battery rack 15, it culminated in an explosion that injured four firefighters. Figure 5 shows the aftermath of the explosion, where thermal runaway spread vertically within rack 15 [37].

Following an analysis of the incident’s data, it was concluded that a series of events contributed to the explosion, and that the fire in rack 15 started in a single-cell module as a result of aberrant lithium metal deposition and dendritic development, which caused a short circuit [37]. This initiated a thermal runaway that spread to adjacent modules, as illustrated in stages 1 through 4 as shown in Figure 6 [37]. The timeline of incidents shown in Figure 6 (a) illustrates the sequence (1 to the 13th) of events leading up to an explosion, whereby there was a delay between 11 and 12, which can be because the firefighters had to assess the situation before they open the door [37]. The explosion was preceded by a significant voltage drop and rising temperatures in rack 15, which triggered fire protection systems and led to a ground fault [37]. Despite the activation of the fire suppression system, APS and Fluence took steps to confirm and investigate the situation. However,

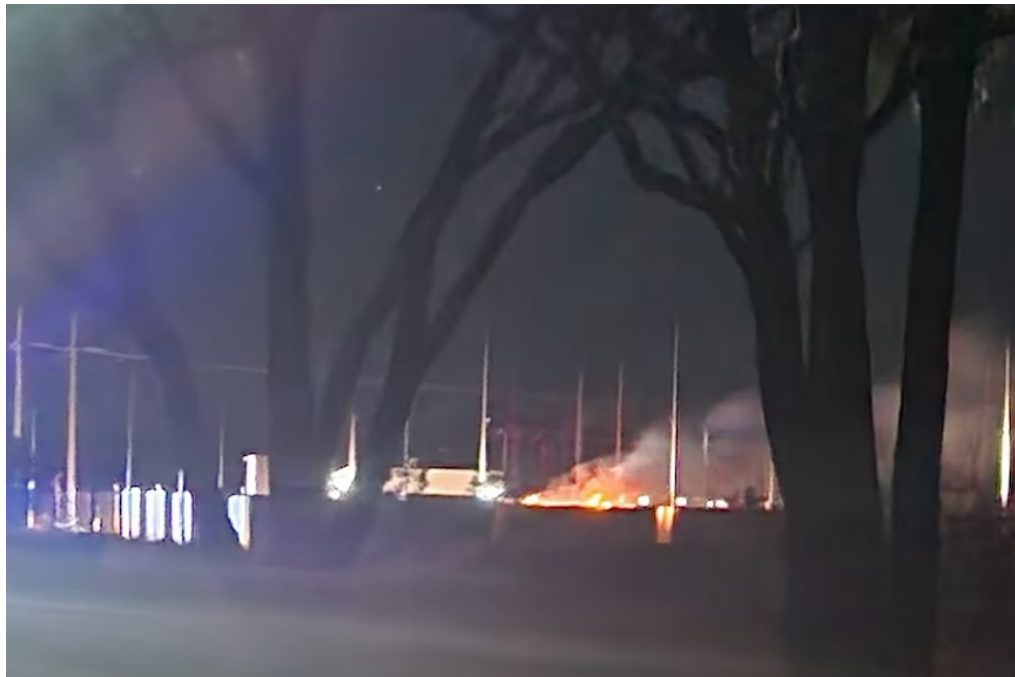
Figure 7. The Australia, Queensland, Bouldercombe fire incident [38].

A fire that was limited to a single Megapack 2.0 module started in the Bouldercombe Big Battery project's lithium battery storage on Tuesday, September 26, 2023, at 19:45 [38]. The incident was described as a minor fire that did not require water to extinguish [38]. The fire only affected a single unit, leaving the other many units unharmed[38]. However, the fire caused dangerous smoke to be discharged into the surrounding region, so locals were advised to stay inside and keep respiratory medications close at hand [38]. By Wednesday morning at 08:20 AM, the Queensland Emergency and Fire Services had successfully contained the fire [38]. Figure 7 show the blaze as it erupted.

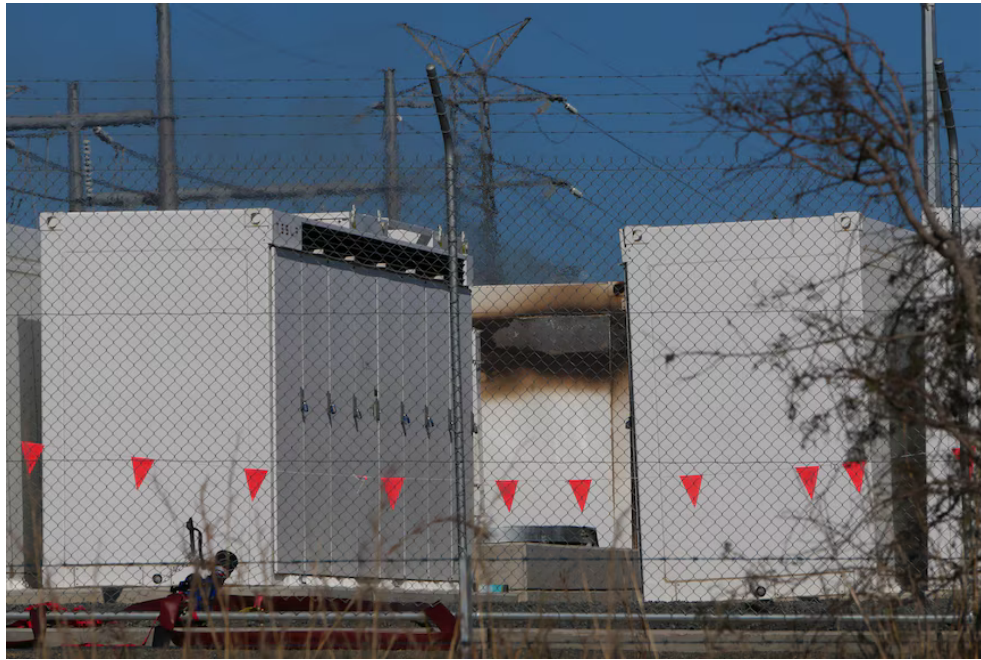
Figure 8. Shows the aftermath of the BESS fire incident in Bouldercombe, Australia [38].

At the time, the cause of the fire was unknown, therefore Genex Power, along with Tesla Motors Australia Pty Ltd and Consolidated Power Projects Pty Ltd, started an inquiry to find out what caused the catastrophe [38]. Residents who witnessed the fire described it as having multicoloured flames with a few bangs and pops [38]. Figure 8 shows the aftermath of the fire incident.

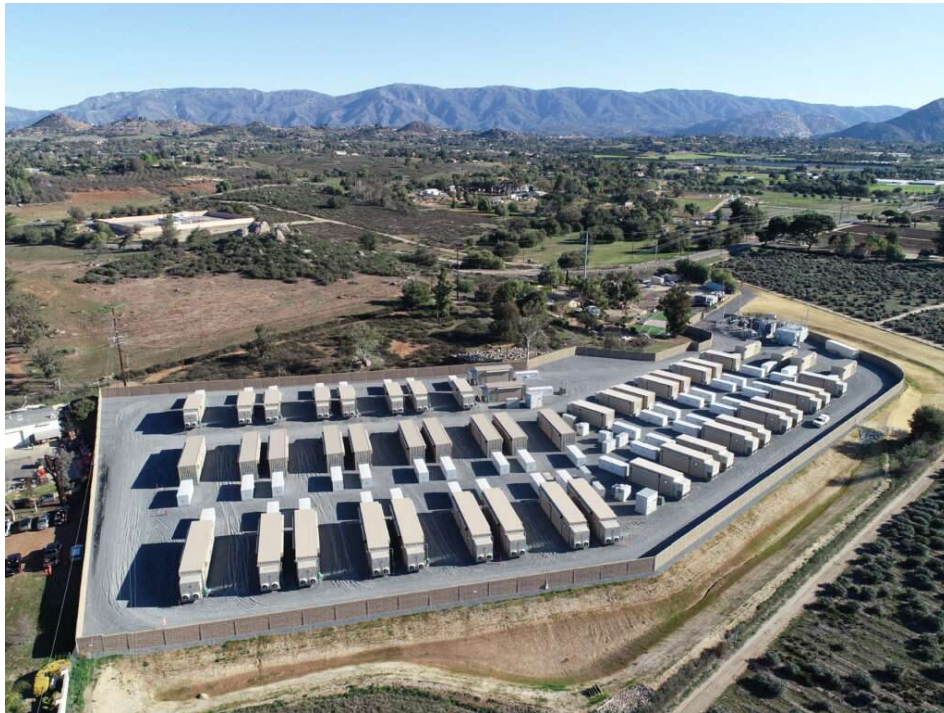
Figure 9. Southern California’s Valley Centre Energy Storage Project [39].

The Valley Center Energy Storage System, a 140MW/560MWh battery storage facility located near San Diego, California, experienced a fire incident on September 18, 2023, at approximately 5:15 pm [39]. The fire broke out in a battery storage unit, equipped with lithium-ion batteries, leading to a dispatch of Fire and Sheriff's departments, road closures, and evacuation orders for the surrounding quarter-mile area [39].

By 9:15 pm, all public safety measures were lifted, with no hazardous conditions detected in the air or water by the San Diego County Hazardous Materials team. This incident follows a previous issue earlier in the year when 100 decommissioned LG lithium-ion battery packs were stolen from the site [39]. Sprinkler system issues that have impacted other large-scale BESS projects, such as the Moss Energy Storage facility, may have contributed to the fire.

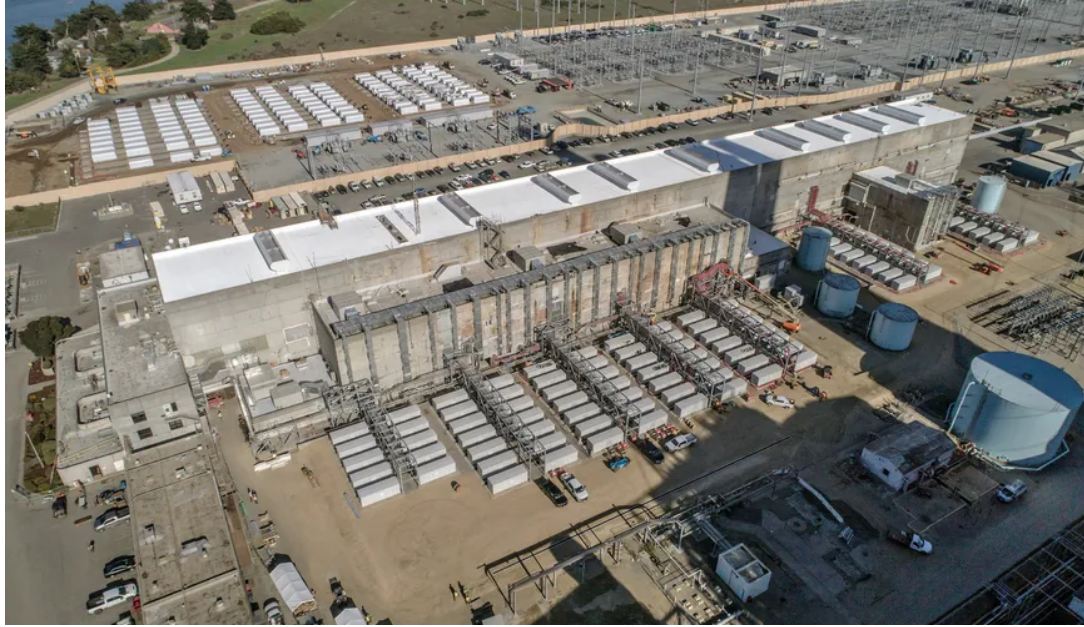
Figure 10. Vistra's Moss Landing energy storage facility (centre) before the incident [41].

The Moss Landing battery complex in California, the largest grid battery installation in the United States, experienced another fire incident on September 20, 2023, barely two years after a previous large-scale accident. This complex includes PG&E's 182.5MW/730MWh Elkhorn plant and Vistra's 400MW, 1600MWh facility, situated at a crucial transmission-grid junction south of the Bay Area [41]. The fire ignited in the early hours of the morning at the Tesla-supplied Elkhorn plant and was contained by the evening. This incident is the latest in a series of fires at this location, with Vistra's facility having suffered two fires in the past year [41]. Figure 10 below shows the ariel view of the facility.

The cause of the fire at the Elkhorn plant was still under investigation, but initial theories suggest a possible issue related to moisture, given the history of similar incidents at Tesla battery installations [41]. The fire did not spread, thanks to the facility's design improvements and effective safety protocols. These procedures include designing techniques to stop fires from spreading from one unit to another and deflagration panels to safely channel hazardous gases. The fire was allowed to burn itself out under controlled conditions, following Tesla's recommended response strategy [41].

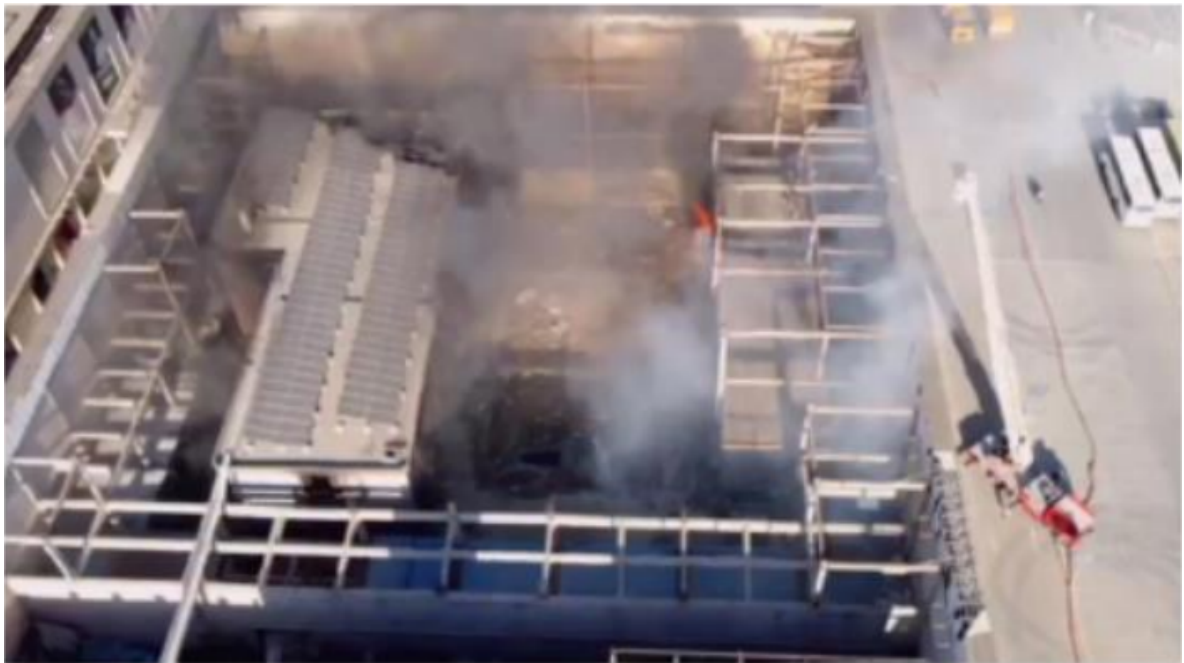
Figure 12. The power station after the fire accident [12].

It was hard to determine what initiated the fire accident due to limited information. Two scenarios were looked at: (1) Did the low-quality batteries cause the fire disaster, or (2) the input overwhelming the batteries, surpassing their carrying capacity [12]. The potential explanations that were put out were as follows: (1) batteries state; (2) energy storage's electrical topology; (3) battery management system (BMS); (4) arrangement of wires and cables; (5) the station's fire protection design; (6) fire water and the station's fire monitoring, warning, and extinguishing system; (7) meteorological environment factors; (8) people on-site system for management and operation [12].

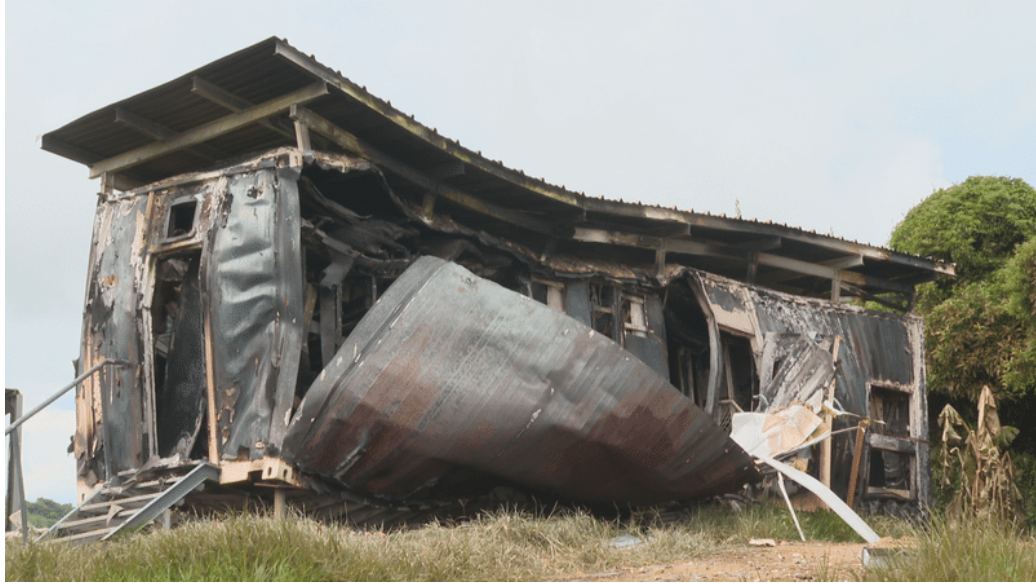
Figure 13. Saint-Esprit, Martinique, France, fire and explosion accident [44].

According to the Territorial Fire and Rescue Service (STIS), the explosion was felt by at least 300 homes around the site [44]. The fire started on the evening of September 29 and lasted until the morning of September 30, 2023. The explosion caused damage to nearby homes, blowing out windows and leading to the evacuation of the residents [44]. The situation on-site was managed and brought under control after three hours, requiring around 20 firefighters supported by EDF (Électricité de France) agents [44]. Toxic fumes from the burning batteries could not be inhaled because the site's perimeter was protected to achieve this, water was first used to create a curtain to protect local residents from toxic fumes [44]. The fire was eventually brought under control with powder and foam containing extinguishing products [44]. Figure 13 shows the damage caused by this disaster.

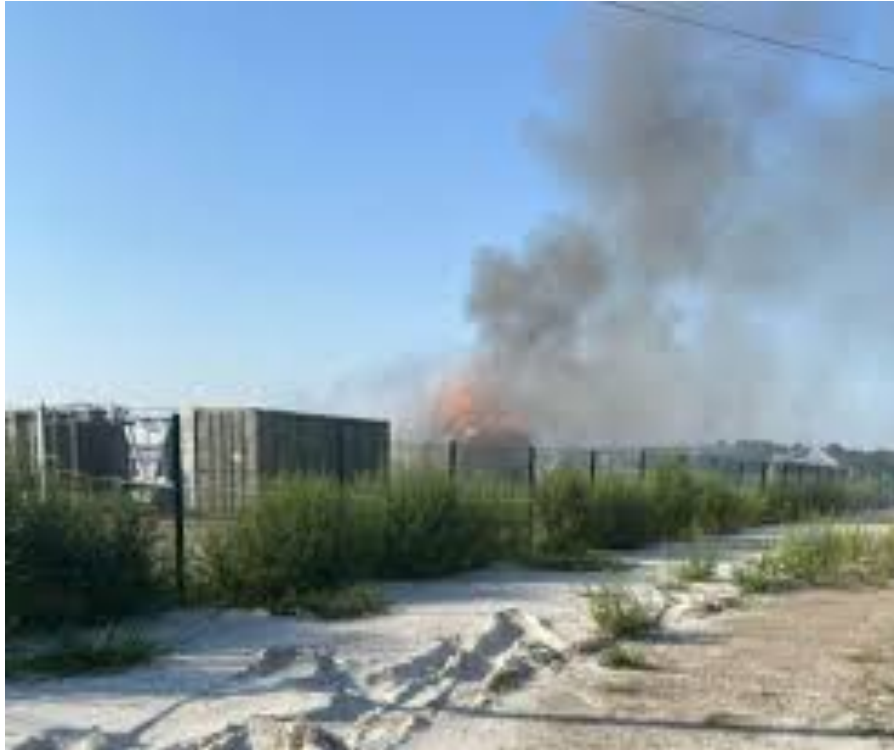
Figure 14. The fire accident at Claudia site [45].

On Tuesday, August 22, 2023, a fire erupted at the end of the morning at the new electricity storage plant in Barban, Saucats, within a container housing lithium-ion batteries [45]. The incident, which occurred amid a recent heat wave, required a day and night of intervention by firefighters [45]. The blaze was visible from several hundred meters away [45]. The fire protection system effectively contained the fire, prevented it from spreading. Gas was used by the firefighters to smother the flames inside the

containers and created a protective curtain, avoiding the use of water due to the nature of lithium battery fires [45]. Figure 14 shows the fire and smoke on the Claudia site.

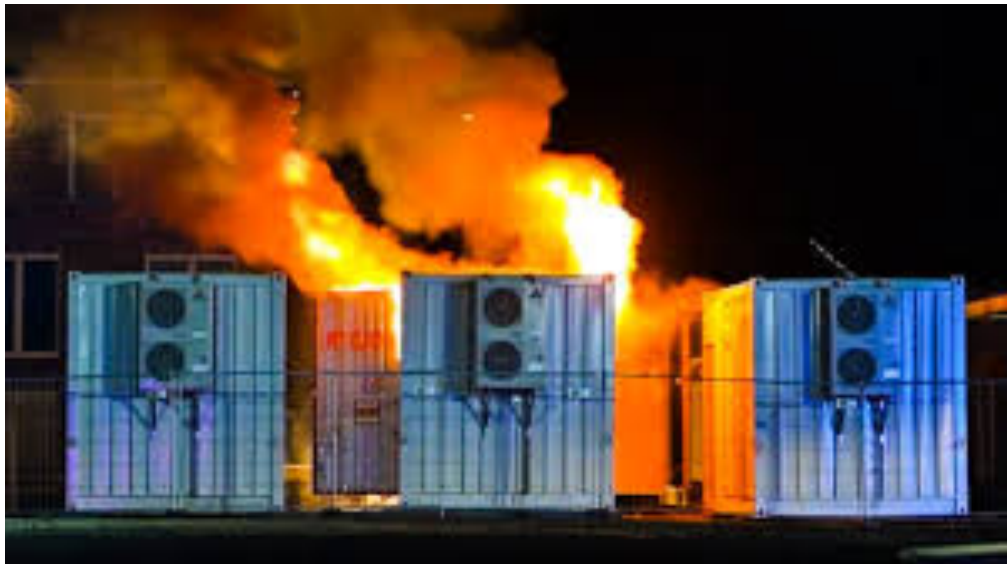
Figure 15. Lithium battery energy storage container caught fire in the business district of Neermoor [46].

On the April 24, 2024, a lithium battery energy storage container caught fire shortly before 9 p.m. in the business district of Neermoor (Lille district), Germany, leaving two firefighters injured [46]. When the firefighters arrived on the scene, they could see light smoke [46]. After consultation with on-site personnel, the energy storage container was opened, leading to an explosion with a flash of flame, injuring the firefighters [46]. A crane was used to move the energy storage container to prevent the fire from spreading to other containers [46].

With the support of fire brigades and police from nearby cities, the fire was finally put out in about 10 hours [46]. Due to the large amount of thick smoke produced by the fire, one of the highways was completely closed off for about 6 hours [46]. Figure 15 shows the scene at the site.

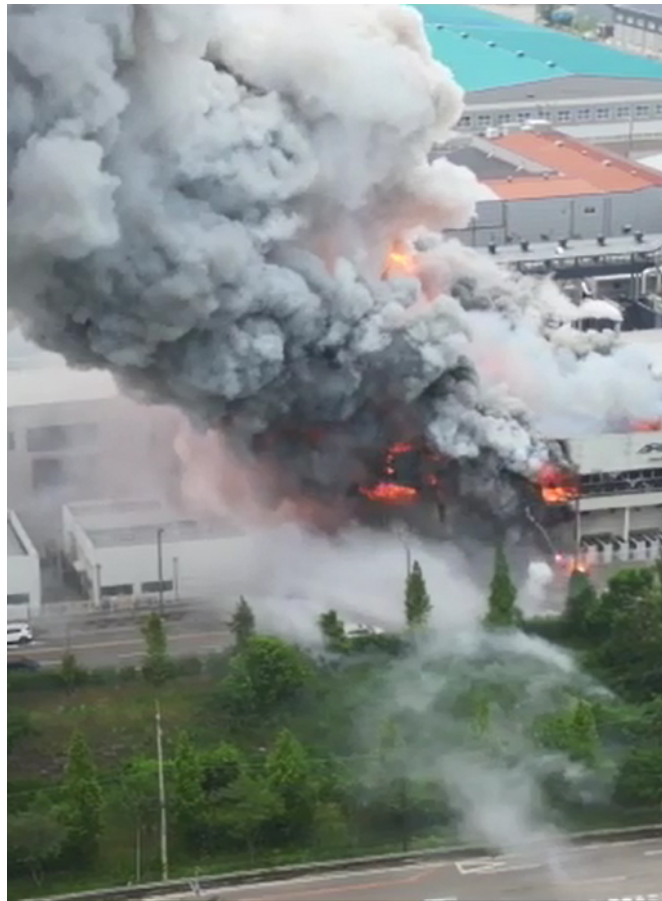
Figure 16. The BESS fire eruption in Hwaseong, Gyeonggi Province [47].

Aricell's lithium battery production facility experienced a fire on June 24, 2024, at 10:31 a.m., caused by exploding lithium batteries [47]. It was reported that the incident left 22 employees dead and injured 8 others. The fire eruption at the battery manufacturing factory in Hwaseong is shown in Figure 16.

The authorities reported that the firemen originally had trouble because the blaze on lithium batteries could not be extinguished with water [47]. Because lithium batteries continuously produce heat within, they can reignite a fire even after it seems to have been

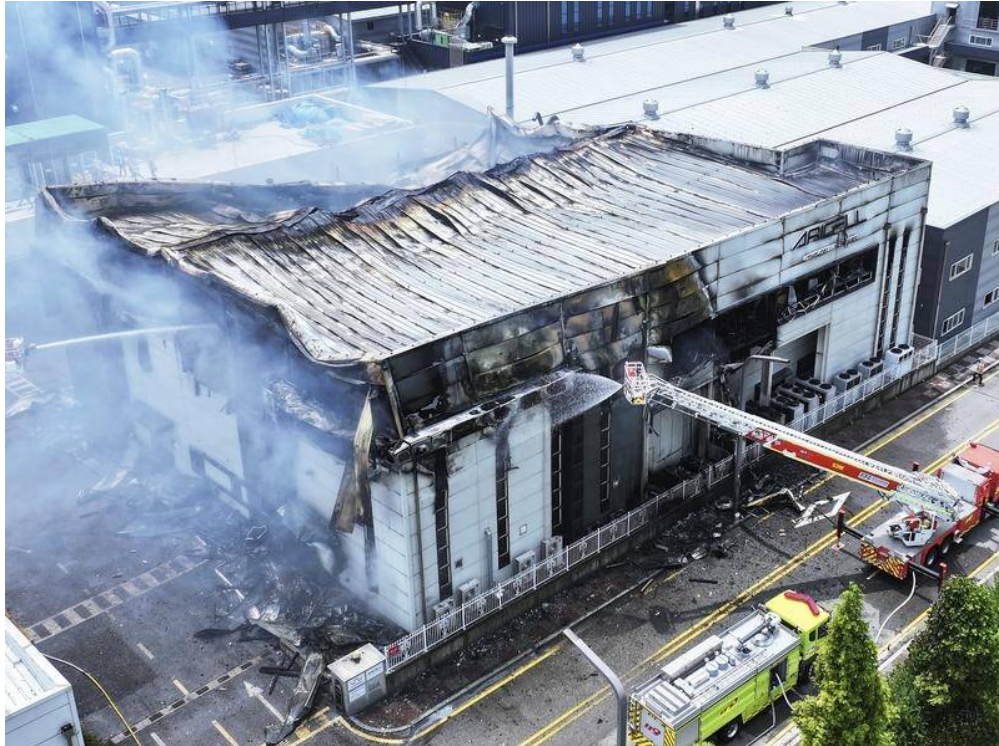
Figure 17. Hwaseong, South Korea, battery fire aftermath [47].

put out, making lithium battery fire challenging to put out [47]. Figure 17 shows the building after the fire was brought under control.

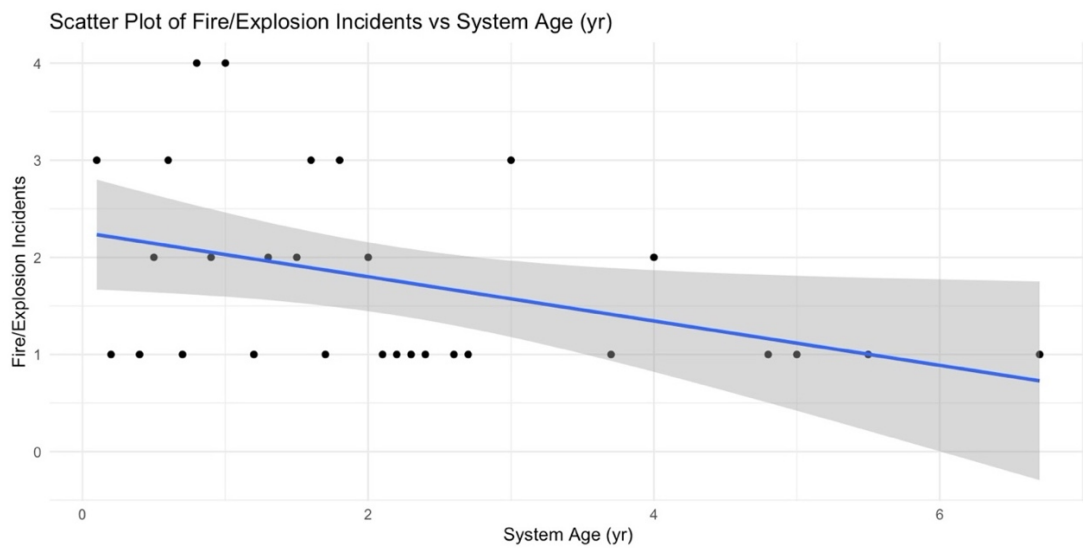
Figure 18. Pearson correlation of Fire and Explosion Incidents and System Age.

In this section, the relationship between fire/explosion incidents and system age (years) of the BESS was analysed. The analysis aims to determine if there is a statistically significant correlation between these two variables, using the Pearson correlation coefficient. The goal is to identify whether older systems experience more incidents compared to newer systems. The Pearson correlation is plotted in Figure 18.

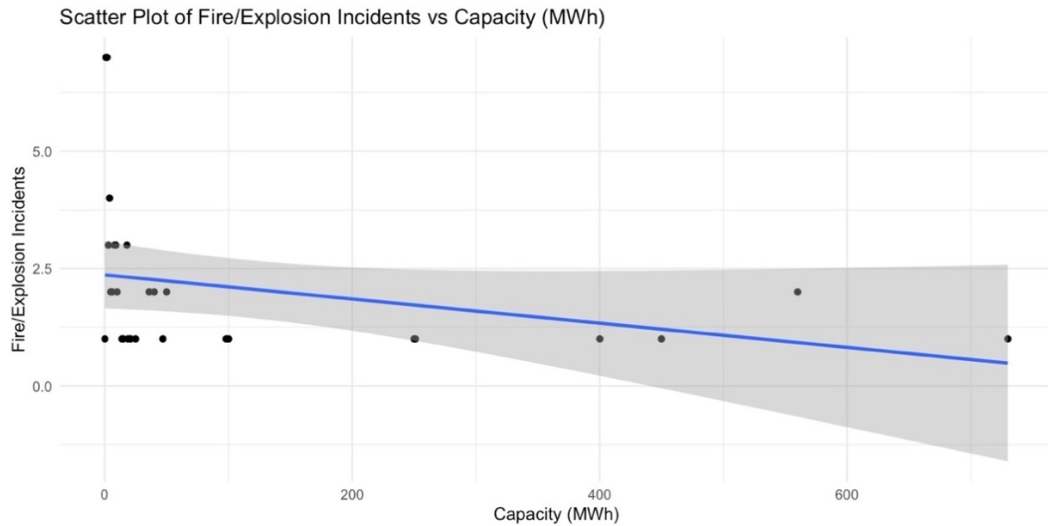
Figure 19. Scatter plot of Fire/Explosion incidents and Capacity (MWh).

The Pearson correlation analysis was carried out in this section, to determine whether is a relationship between the capacity (MWh) of the BESS and the occurrence of fire/explosion incidents. Aiming to investigate whether larger capacity systems are safer or more prone to incidents compared to smaller capacity systems. By exploring this correlation, we can better understand whether system capacity plays a significant role in the risk profile of BESS installations. The Pearson correlation is plotted in Figure 19.

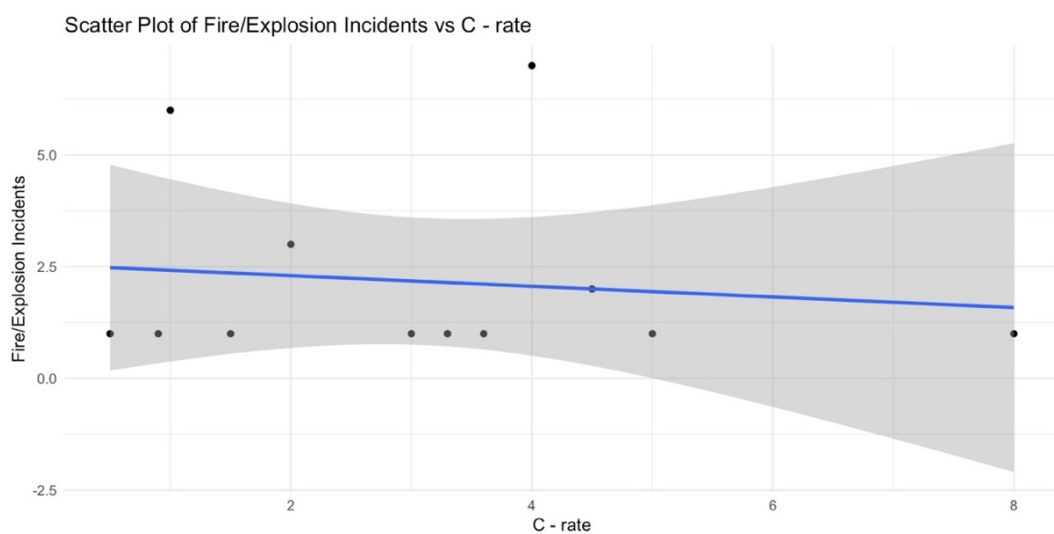
Figure 20. C – rate and the Fire/Explosion Incidents scattering graph

The graph or scattering presented in figure 20 present a relationship between C – rate of BESS and the number of fire/explosion incidents, whereby, C – rate on the x-axis represents the charge or discharge rate relative to the battery’s maximum capacity. The blue line represents a linear regression fit to the data points, indicating a weak negative correlation between the C – rate and fire/explosion incidents. As the C – rate increases, the number of incidents tends to decrease slightly (this could be due to data limitations).

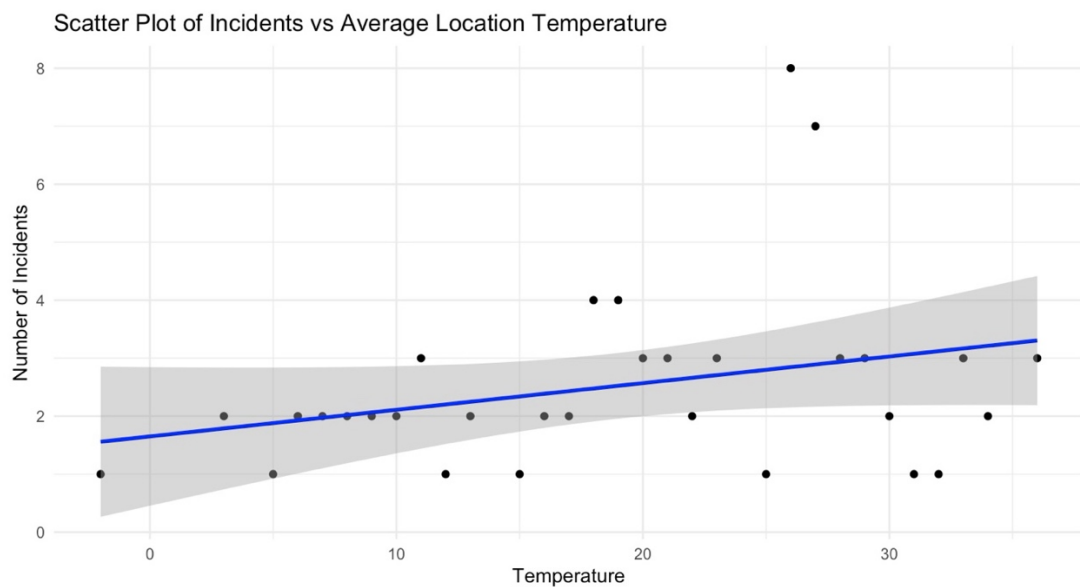
Figure 21. Scatter plot of Fire/Explosion incidents and Average Location temperature (°C)

In this section, the relationship between fire/explosion incidents of the battery energy storage system (BESS) and average location temperature (°C) was analysed. The analysis aims to determine if there is a statistically significant correlation between fire/explosion incidents and average location temperature, using the Pearson correlation coefficient. The goal is to identify whether locations with high average temperature experience more incidents compared to location with lower average temperatures. The Pearson correlation is plotted in Figure 21.

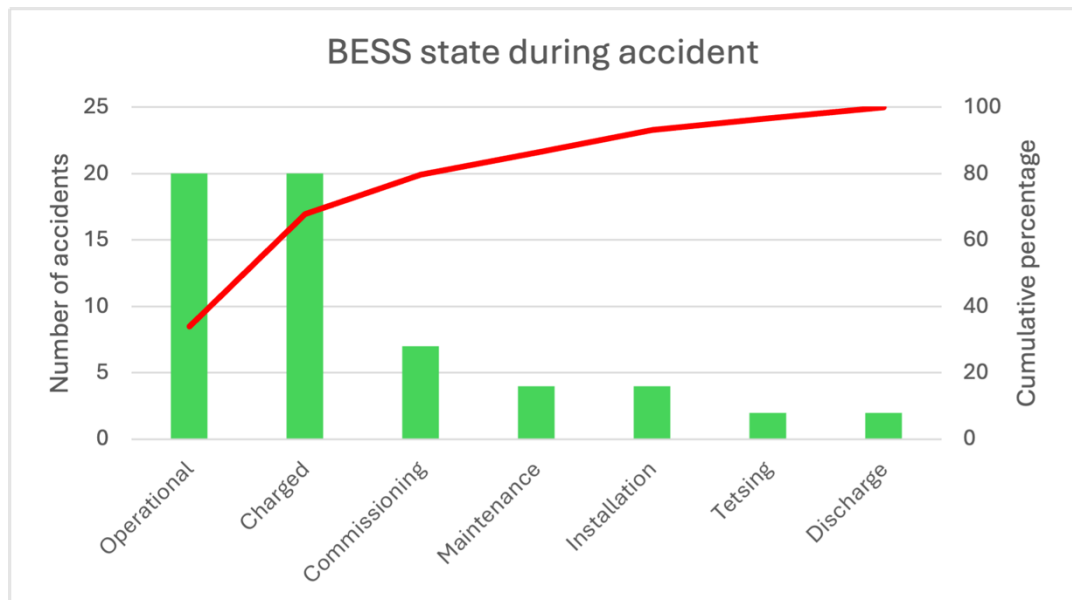
Figure 22. Analysis of Battery Energy Storage System States during Accidents.

The distribution of incidents by different operational states are presented above, whereby, it indicates that the highest risks of fire/explosion incidents occur when systems are in their operational or charged states, likely because these are the most demanding and dynamic phases for equipment. This implies a need for enhanced safety measures and monitoring during these states to mitigate risks. States involving transitions or controlled processes, such as commissioning and testing, are less risky but still require attention to prevent incidents.
