**ASSESSMENT OF FLOODWATER HARVESTING  
INFRASTRUCTURES IN THE NAMIBIAN CUVELAI-ETOSHA BASIN**

A MINI-THESIS SUBMITTED IN PARTIAL FULFILMENT  
OF THE REQUIREMENTS FOR THE DEGREE OF  
MASTER OF SCIENCE IN WATER RESOURCES MANAGEMENT

The main objective of the study was to assess the condition and performance of Floodwater Harvesting Infrastructures in the Cuvelai-Etosha Basin. The Ministry of Agriculture, Water and Forestry constructed 34 earth dams in this Basin from 2008 to 2011. Out of these newly constructed earth dams, 18 were randomly selected for the study. The research design was based on using both qualitative and quantitative data on a completely randomised basis. Sentinel data was used to identify the water bodies by means of remote sensing. Information was gathered by means of structured interviews from the locals or people acquainted with the sites. The results from the interviews taken among 96% of the participants showed that the highest usage of earth dams is livestock watering while few people use them for irrigation purposes.

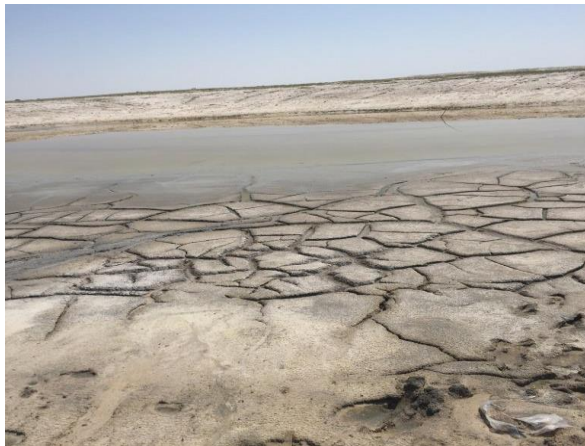
The earth dams are very helpful to the people, except for the Ontako dam where the community members claimed it is not helpful to them. This is due to high salinity that both animals and people cannot consume it, as well as the fact that the dam does not retain water for long (less than 6 months).

**Figure 4.5 Siltation in Ontako**

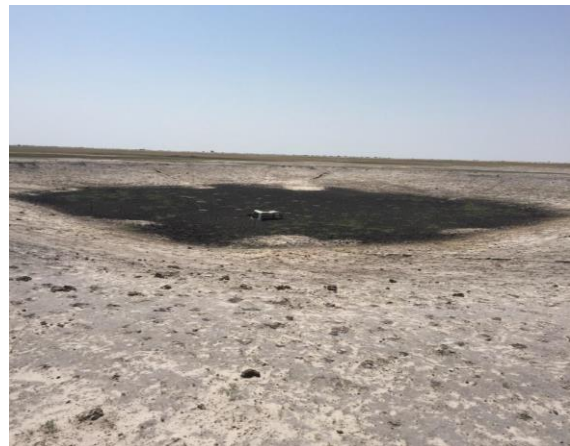
**Figure 4.6 Sigopi earth dam silting up**

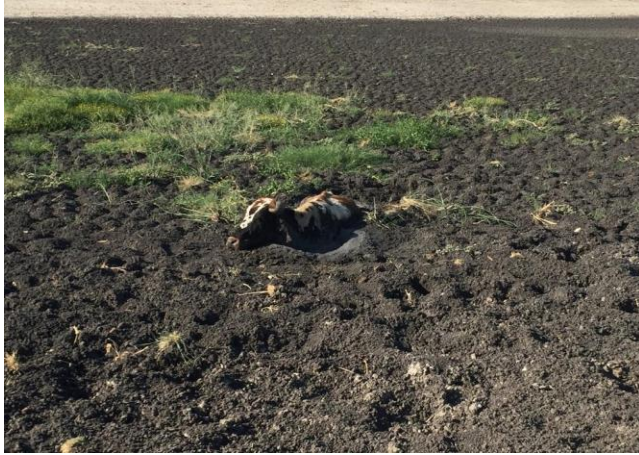
The earth dams are very helpful to the communities, but also unsafe due to the sedimentation in them. At some parts it looks dry, but when the animals step close, they get stuck in the mud and cannot manage to get out. About 94.3% stated the importance of the earth dams and how helpful they are to the communities. There are no challenges faced by 65.8% of the participants, 2.8% of them reported diseases such as malaria and flooding or overtopping of the dams, 28.6% reported other accidents including drowning of animals in the dams.

**Figure 4.7 Animal stuck in Oshaaneko earth dam**

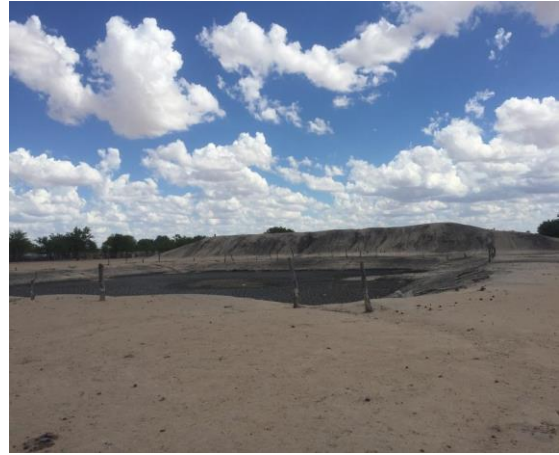
**Figure 4.8 Enongo earth dam**

The earth dams used in the study had an average area of 2809.8 m<sup>2</sup>. Small amount of water was observed in these dams except for Enonogo and elondo which were completely dry during fieldwork. Their areas are relatively large and this suggests that the large surface areas of the earth dams contribute to higher evapotranspiration rates, which is made worse by the low rainfall for 2019 as indicated in Fig.3.2, the study area only received an average rainfall of 108.58 mm. In India they have multiple small dams [30], length is 10m, width is 1m and the depth of 5m. This depth and surface area encourage low evapotranspiration. The sides of the dams are reinforced with bamboo posts and mats to reduce siltation and maintain water quality and quantity. In Ethiopia [20], most of the water harvesting ponds had a volume of less than 1,500 m<sup>3</sup> to reduce the rate of evapotranspiration and could have water for longer periods.

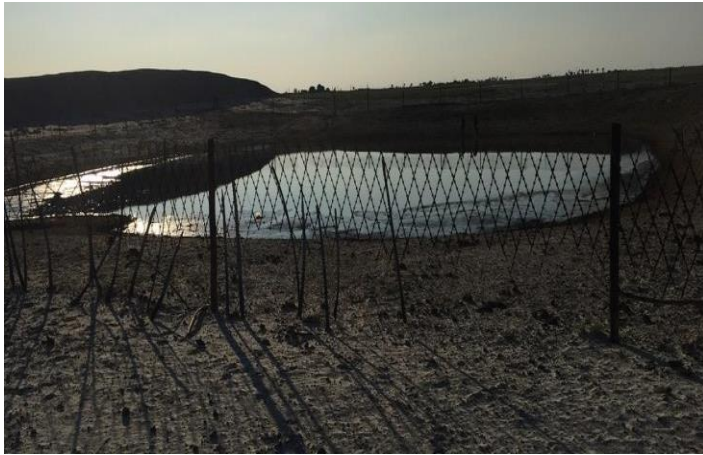
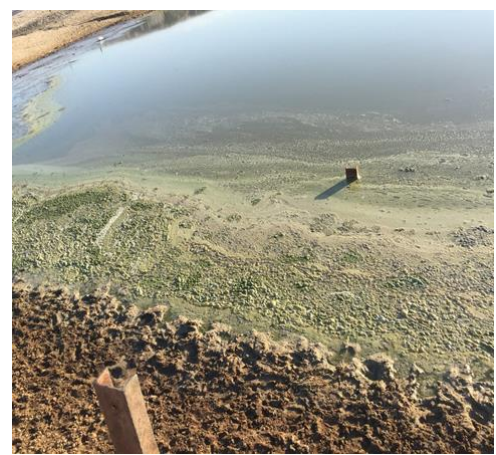
**Figure 4.9 (a) Earth dam fenced off in Ontaanda and its water quality (b)**

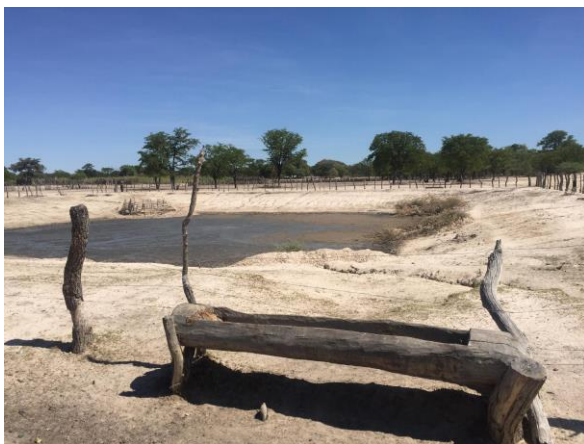
**Figure 4.10 (a) Ekangolangobe earth dam**

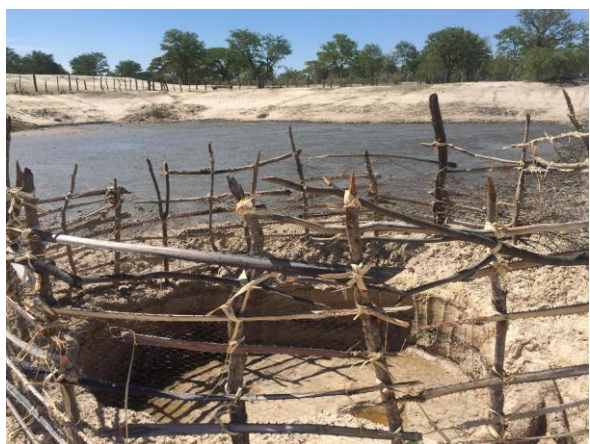
**Figure 4.10 (b) Ekangolangobe close up**

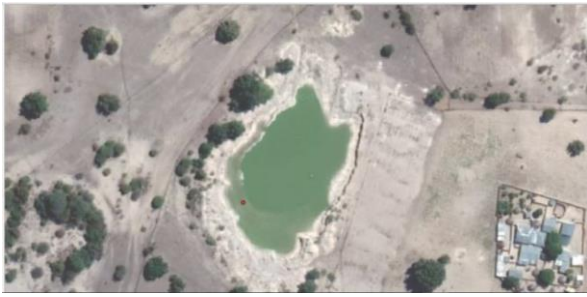
**Google Satellite images of the corresponding earth dams, 22 September 2019**

**Figure 4.12 Satellite image of Ontako**

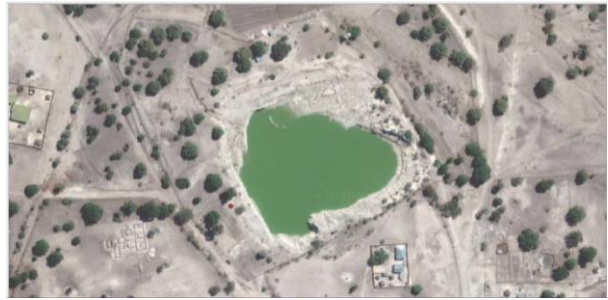
**Figure 4.13 Satellite image of Oshaaneko**

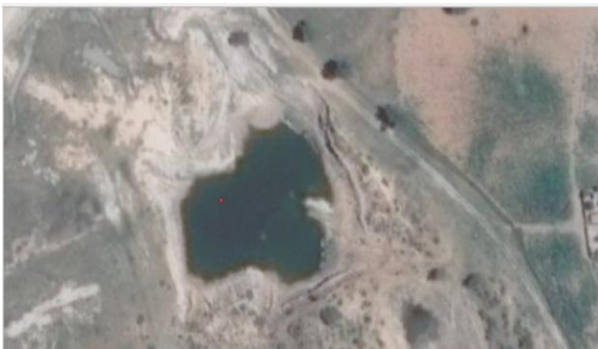
**Figure 4.14 Satellite image of Sigopi**

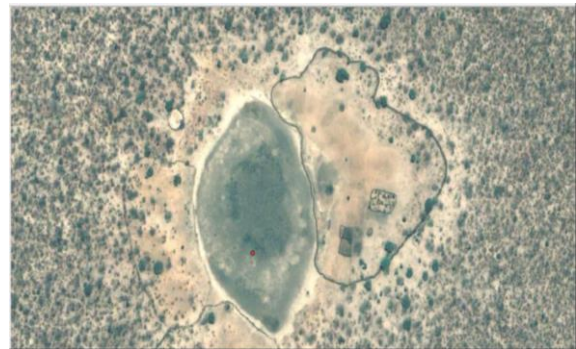
**Figure 4.15 Satellite image of Enongo**
